## EXPERIMENTAL RESEARCHES CONCERNING CERAMIC POST INSULATORS DAMAGE USED IN 110V HIGH VOLTAGE SWITCHES

### Abstract

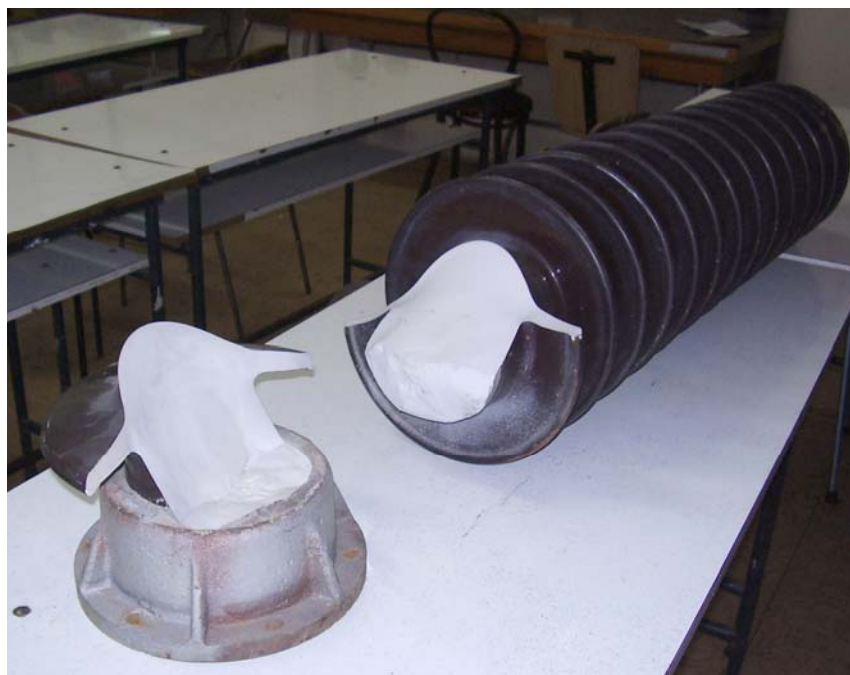
. Electrical field events collected during a long period, 01.01.2005 – 01.06. 2006 showed that, some of these Ceramic Post Insulators have been broken in exploitation, both at the upper metallic cup and at the bottom metallic support of the ceramic rotating insulators. In fig. 3.1 is presented such an accident.

The brakes were located at the upper metallic cup, most of them and also at the bottom metallic support.

Fig. 3.1. – Ceramic Insulator braked from the metalic bottom support
