## EXPERIMENTAL RESEARCHES CONCERNING CERAMIC POST INSULATORS DAMAGE USED IN 110V HIGH VOLTAGE SWITCHES

### Abstract

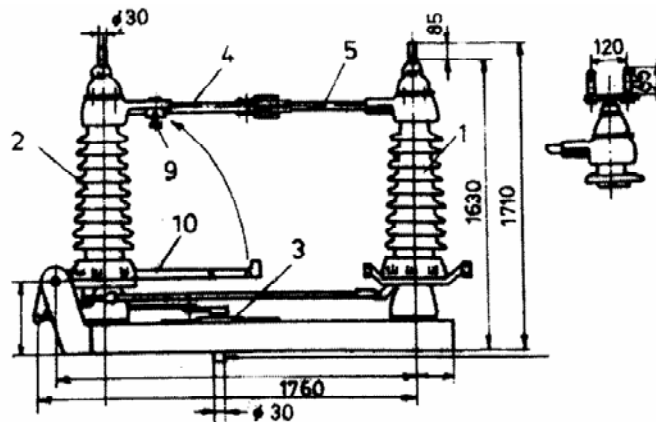
Fig. 1.1. - Schema of an 110 kV Rotative High Switch

Engineering schema of such a Rotative Switch is presented in Fig.1.1 and its connecting pole is enclosed.

Ceramic Insulators 1, 2 can swivel, turning round with 90° under the action of a mechanic or an electrical device 3. On the rods 4 and 5, are set electrical contacts 6, 7 and 8, as they are presented in fig. 1.2..
